AFFIDAVIT

# Epsilon E-Steer Sensor History of Furukawa Slip Ring Plating Change

- Action Title: Slip Ring Plating Analysis Report
- Start Date: 14JA04
- End Date: 11FE04
- Brief Summary:
  - Material analysis of slip rings and contact brushes on samples from warranty, virgin production, and column validation (PV3) wear life testing.

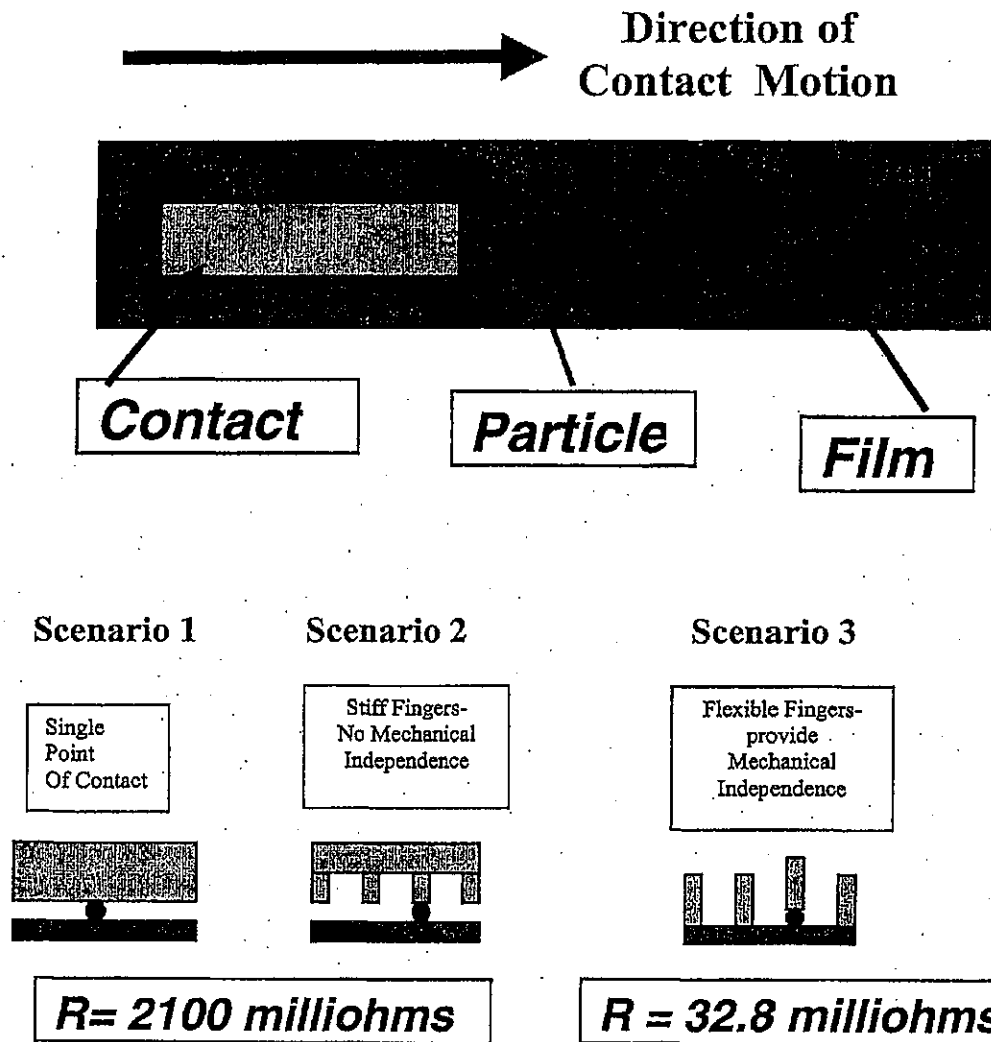
**Figure 17**  
Illustrations of how contact fingers can interact  
with particles and surface films

However, the most important design consideration is that the wires all have mechanical independence as well as the parallel electrical path. The importance of this is illustrated in figure 17. The drawing suggests what could happen if the contact rides over an area where there is a uniform tarnish film equivalent to 100 milliohms and a highly resistive particle with a 2 ohm (or 2000 milliohm) resistance. For the single point of contact (scenario 1), both the particle and the film act as a series resistor. The overall resistance is then the sum of the two values or 2100 milliohms. If the contact is designed properly, and the individual wires have enough mechanical independence such that the particle only lifts up one wire, the net resistance is very similar to  $n-1$  parallel contacts. For the example shown (scenario 3), there are four parallel contacts, and as noted in the example found in the previous figure, this would have a net resistance of 25 milliohms in the absence of the particle. However, the particle effectively negates most of the current flow from the lifted leg, this acts very similar to a three parallel contact construction (i.e.- 32.8 vs. 33 milliohms). A similar analysis with nine wires indicates that if only one of the nine

However, a far more damaging scenario is illustrated by scenario 2 in figure 17. In this case, the wires do not have mechanical independence, and as a single wire rides over the particle, the rest of the wires are lifted off the film. This results in a single point of contact. This can occur when the relative stiffness of the individual wires is too high in comparison to the supporting spring. It may be helpful to think of this construction as a supporting arm (BeCu spring) with fingers (Palliney wires) at the end of the arm. The design issue is to make sure the "fingers" are flexible enough to allow independent movement over any potential obstacle. If the fingers are too stiff, as one or more of the fingers try to deflect up and ride over the obstacle, they actually lift the other fingers off of the opposing substrate and the electrical path moves from a parallel to a series path. In terms of the schematics seen in figure 17, we move from scenario 3 to scenario 2, and the potential for large noise spikes increases dramatically. Because differences in thickness, width and cross section all effect the section modulus of a cantilever spring, accurately modeling the exact geometry shown in figure 12 is difficult and outside the scope of this report. However, it is possible to provide some directional guidance on the design issues for this style contact.

In order to maximize the advantages of parallel conduction paths, it is necessary to ensure that the relative spring rates for the fingers and associated support arm are set correctly. First, the spring rates on the fingers should be set so that each finger has enough flexibility to "climb" over the height of the anticipated particulate/film layers. This must be done without either 1) plastically deforming the finger, or 2) generating enough spring force to lift the supporting arm to the point where the remaining fingers lose contact with the mating surface (i.e.-scenario 2 in figure 17). Also, the total gram force on the fingers (sum of the force resulting from both the finger deflection and the arm deflection) balanced so it acts to mechanically dislodge/disrupt most particles and films, but does not cause excessive wear of the mating surface. Based on our experience with Palliney contacts in other automotive applications, we generally recommend something in the range of 2.5-5 g per point of contact. However, we do not have any experience with the PTFE co-deposited Au. Most of our experience is based on mating to polymeric based resistive inks. For nine wires, our generalized recommendations would place the total gram force in the range of 22.5 to 45 grams.
